**STUDY OF MAINE
UNDERGROUND STORAGE
SYSTEM
ANNUAL INSPECTION REPORTS**

Maine Department of Environmental Protection

MARCEL MOREAU ASSOCIATES

July 2000

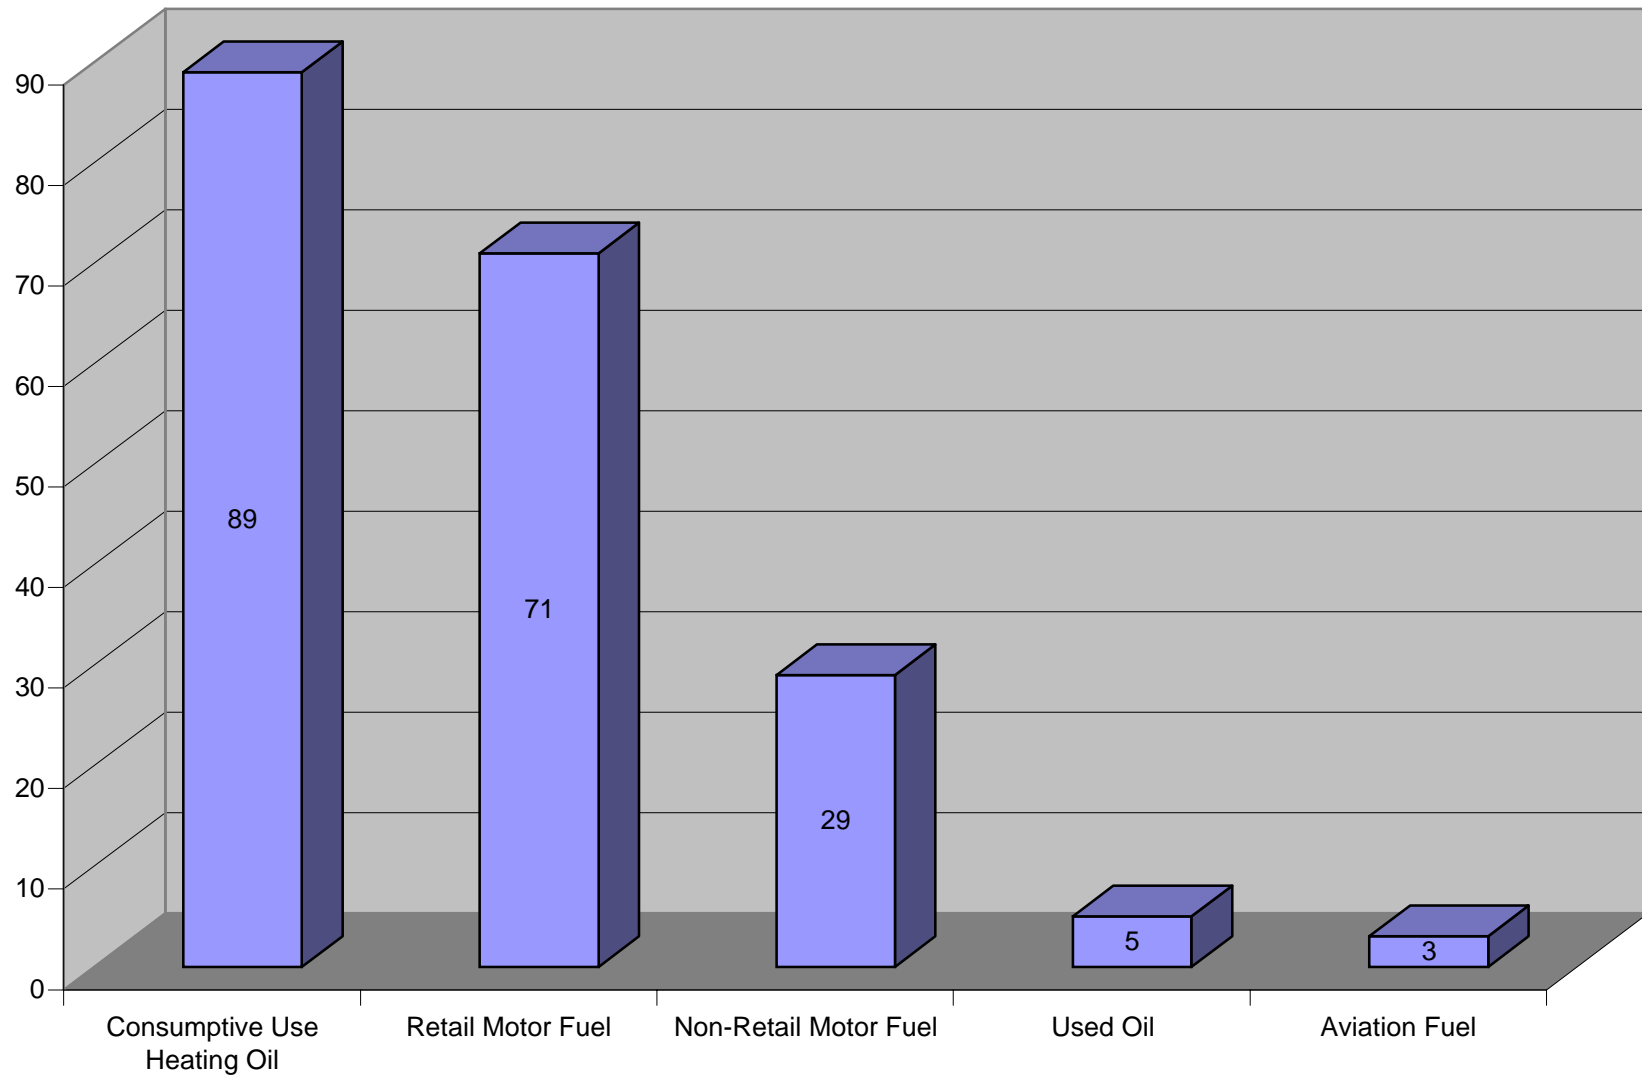
Figure 1. What Were the Facility Types Included in the Study?

Figure 1 and the table above were calculated based on the 190 facilities where annual inspection reports were analyzed. The total number of facility uses is greater than 190 because some facilities had multiple uses.

The facility use categories contained in the DEP data base differ from the categories used in this study, so the percentages in the table cannot be directly compared to the percentages present in the entire tank population data base.

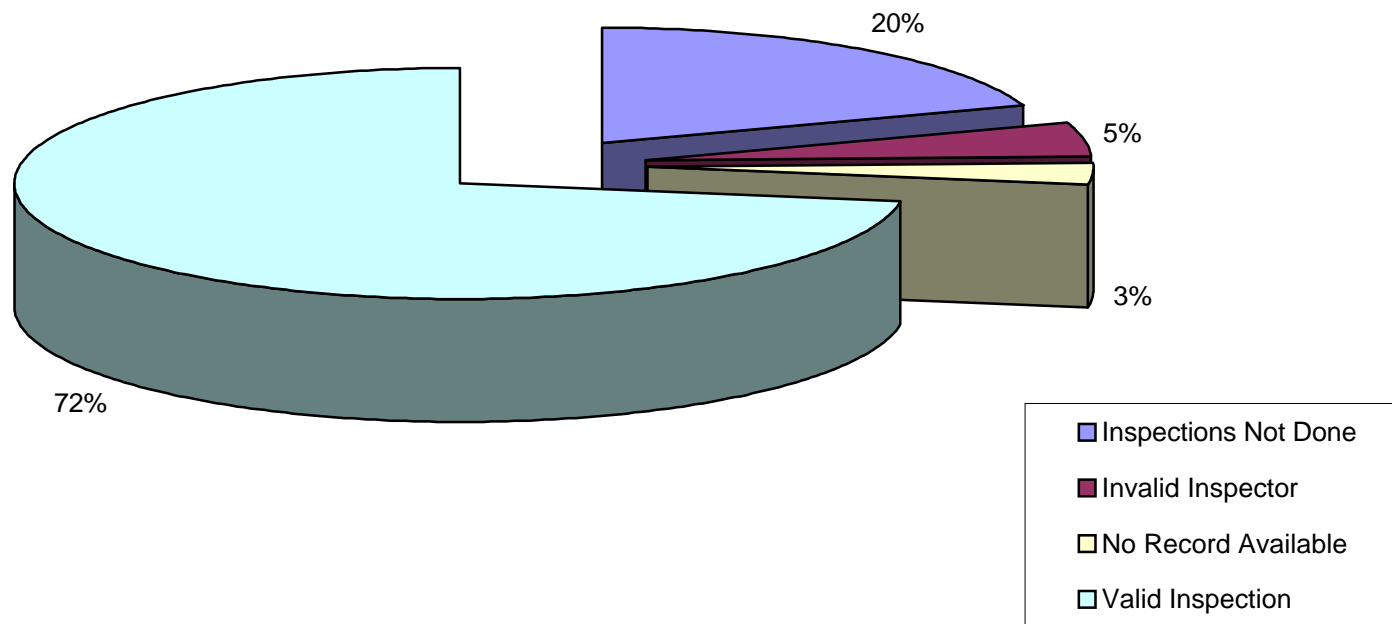
Figure 2. What Percentage of UST Facilities Had a Valid Annual Inspection Conducted in 1999?

Five percent of the facilities had an annual inspection conducted by an unqualified person. Maine regulations specify that the inspection must be conducted by a Maine certified tank installer, a manufacturer trained representative of the owner or an authorized representative of the manufacturer. There were twelve facilities in the study sample where the person conducting the annual inspection did not fall in any of these three categories.

Of the facilities included in this study, 202 facilities had inspection reports that could have been submitted to the DEP. This number includes 190 facilities with valid inspections and 12 facilities where inspections were conducted by unqualified inspectors (See Figure 2). For these 202 facilities, only 53 UST owners voluntarily sent in their annual inspection reports.

Because submission of the annual inspection report to the DEP is not required by regulation, most UST owners do not report the results of the annual inspection to the DEP. While the data show that many tank owners conduct the annual inspection even though they do not submit the report to the DEP (See Figure 2), the lack of information concerning the annual inspection makes it difficult for the DEP to identify facilities that were not inspected and to follow up on those facilities where problems are reported to see if the problems are remedied.

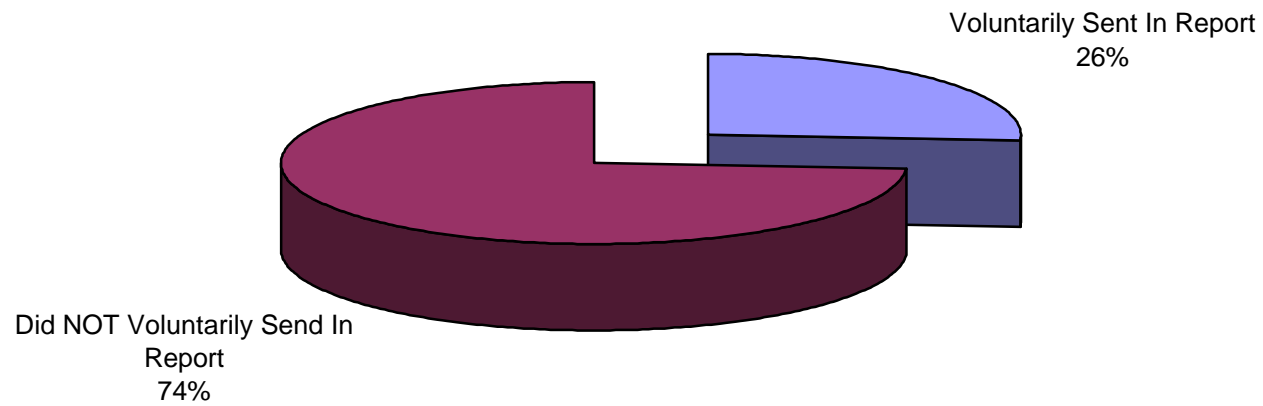
Figure 3. What Percentage of Facility Owners Voluntarily Sent in Their Annual Inspection Reports in 1999?

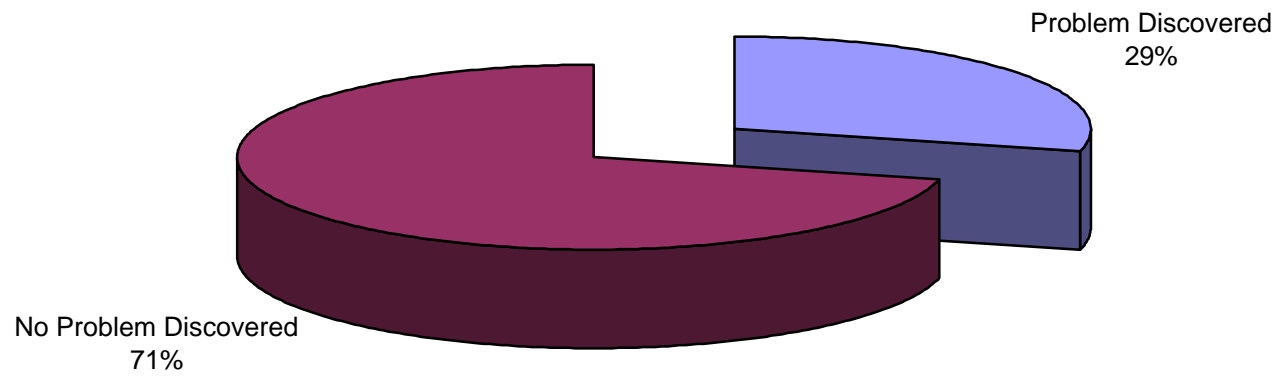
Figure 4. What Percentage of 1999 Annual Inspections Discovered Problems?

Of the 190 annual inspection reports reviewed, 29 percent discovered problems with the facility. This number is very likely an underestimate of the true number of problems because some problems are probably corrected during the inspection but are not recorded on the inspection report. Thus the 29 percent of facilities with problems discovered in 1999 is most likely a conservative estimate of the number of facilities where problems actually occurred.

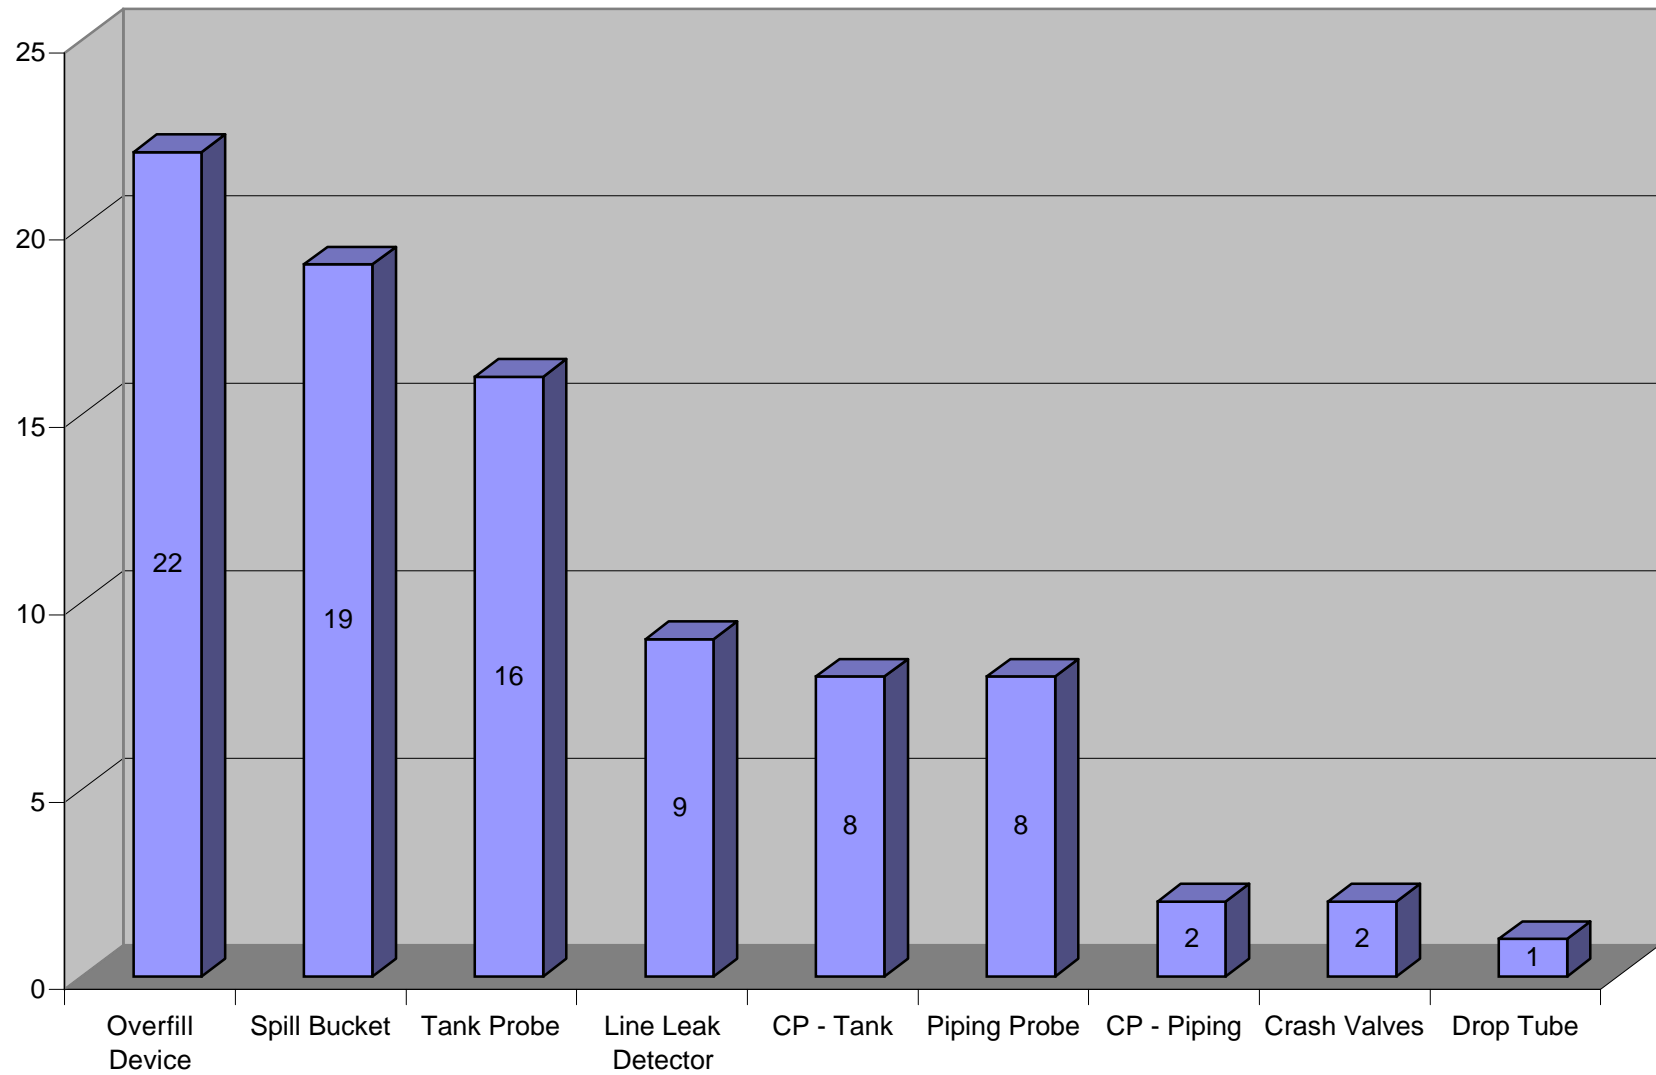
Figure 5. What kinds of Problems Were Discovered During Annual Inspections in 1999?

Figure 5. What Kinds of Problems Were Discovered During Annual Inspections in 1999?

A total of 87 separate problems were discovered at 55 of the facilities included in the 1999 sample of annual inspection reports. The types of problems that were identified for each problem category are described in Appendix B.

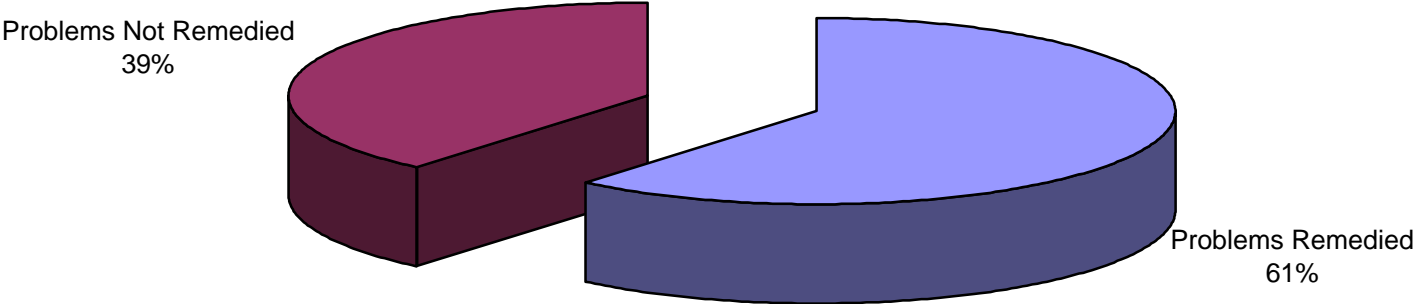
Figure 6. How Many Problems Identified During 1999 Annual Inspections Were Remedied?

The status of the ten cathodic protection problems identified in the inspection reports was not determined as a part of this study. This is why the number of problems where the present day status of the problem is known (77) is different from the number of problems discovered (87). Of the 77 problems whose status is known, 47 (61%) were remedied and 30 (39%) were not remedied.

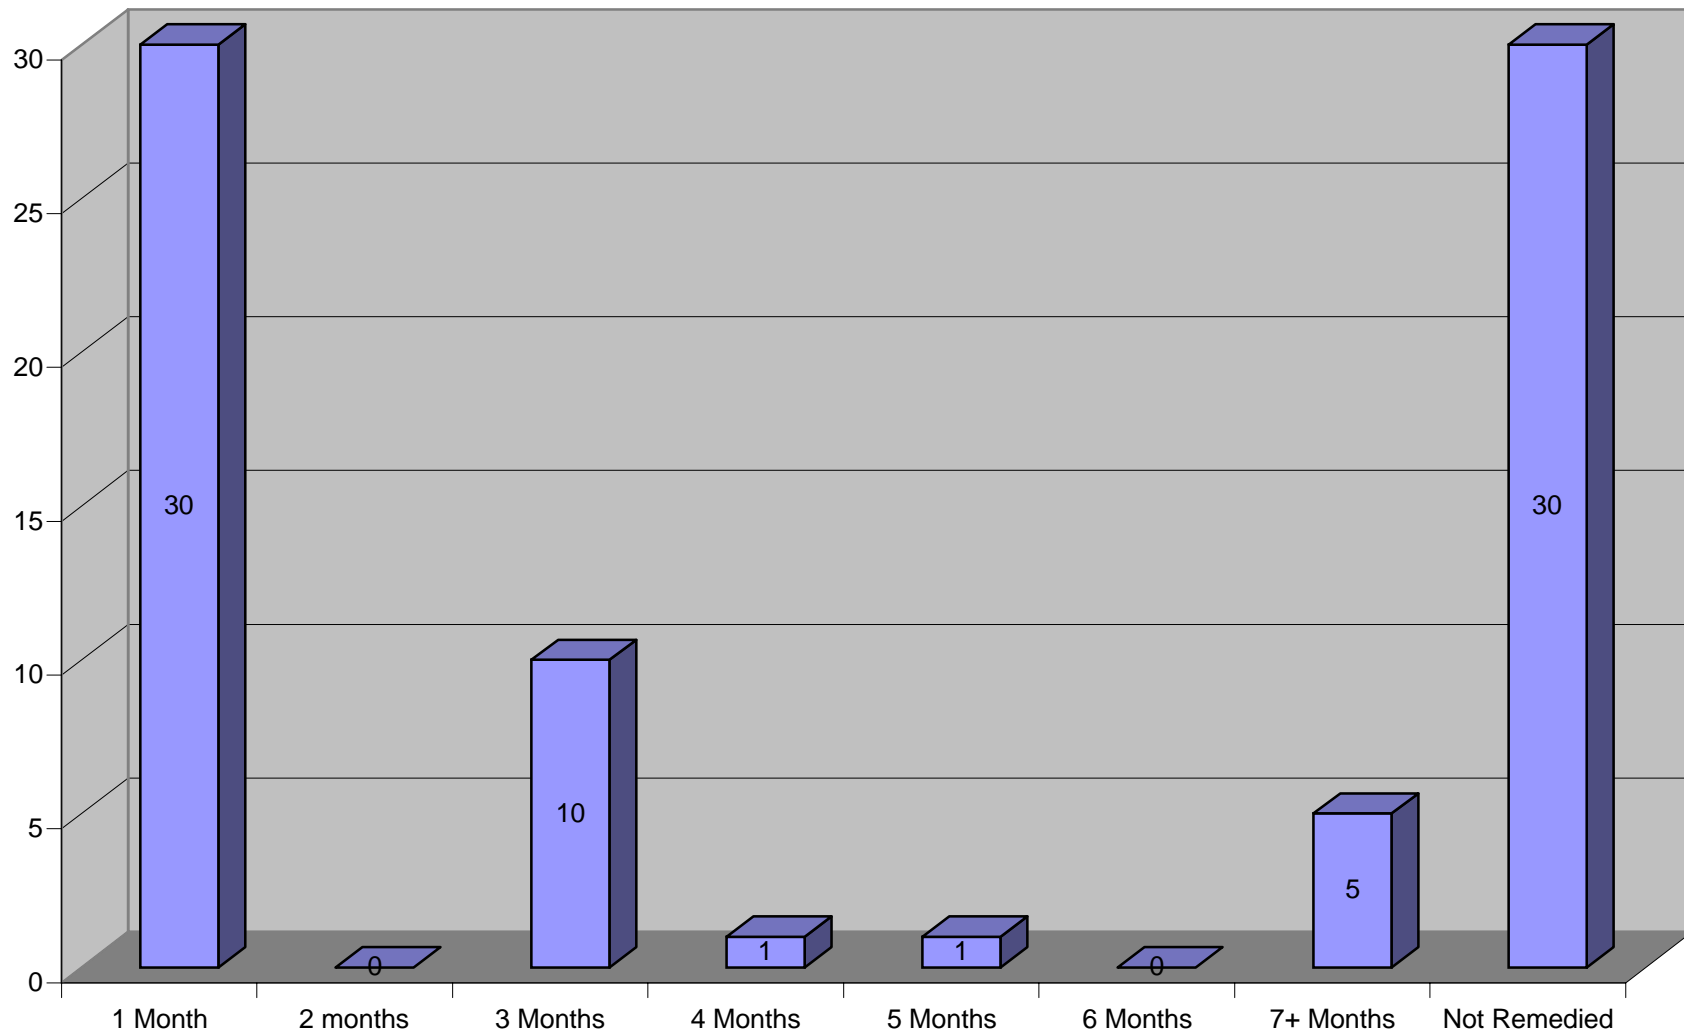
Figure 7. How Long Did It Take for Problems Identified in the 1999 Annual Inspection Reports to be Remedied?

Of the problems identified during annual inspections in 1999, 30 (39%) were repaired within the first month. Most of these were probably repaired at the time of the inspection.

An additional 12 problems (16%) were remedied in the two to six months following the annual inspection. Five problems (7%) were remedied 7 months or more after the date of the annual inspection. Note that the date of repair is based on telephone interviews with the inspectors, and is dependent on the inspector's recollection. Thus there is likely some error in the estimated time to remedy a problem.

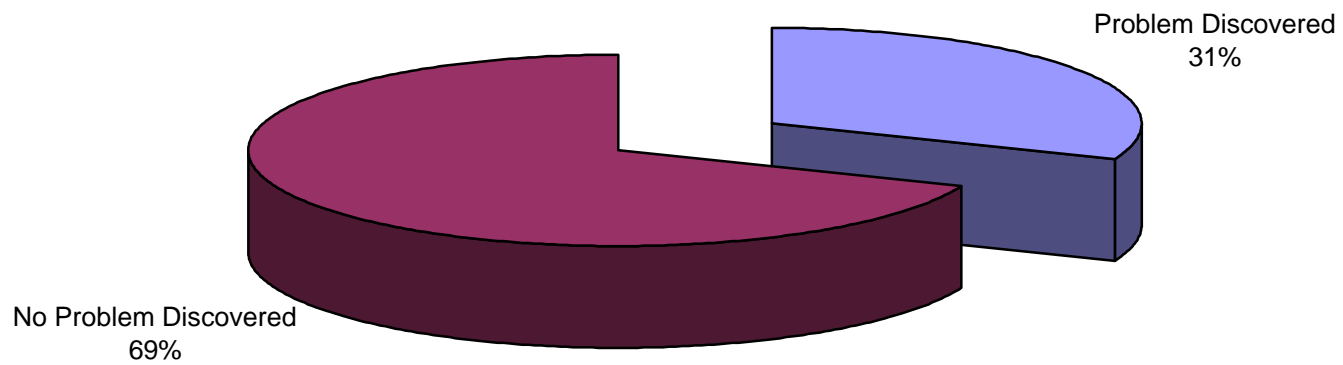
Figure C-1. What Percentage of 1999 Annual Inspections From a Single Owner Discovered Problems?

Figure C-1. What Percentage of 1999 Annual Inspections from a Single Owner Discovered Problems?

NOTE: The person conducting the annual inspections for the single owner facilities was instructed to record all problems discovered, whether or not they were included in the DEP's annual inspection checklist. As a result, some 14 additional problems were discovered, including corroded electrical fittings, riser pipes that were too close to grade, missing vent caps, worn out dispensing hoses, improperly programmed equipment and flexible connectors not protected against corrosion. These problems were not included in Figures C-1 and C-2 because they were not recorded in the 1999 random sample of inspection reports. If these problems are included in the single owner statistics, then 14 facilities (48%) had a total of 27 problems identified.

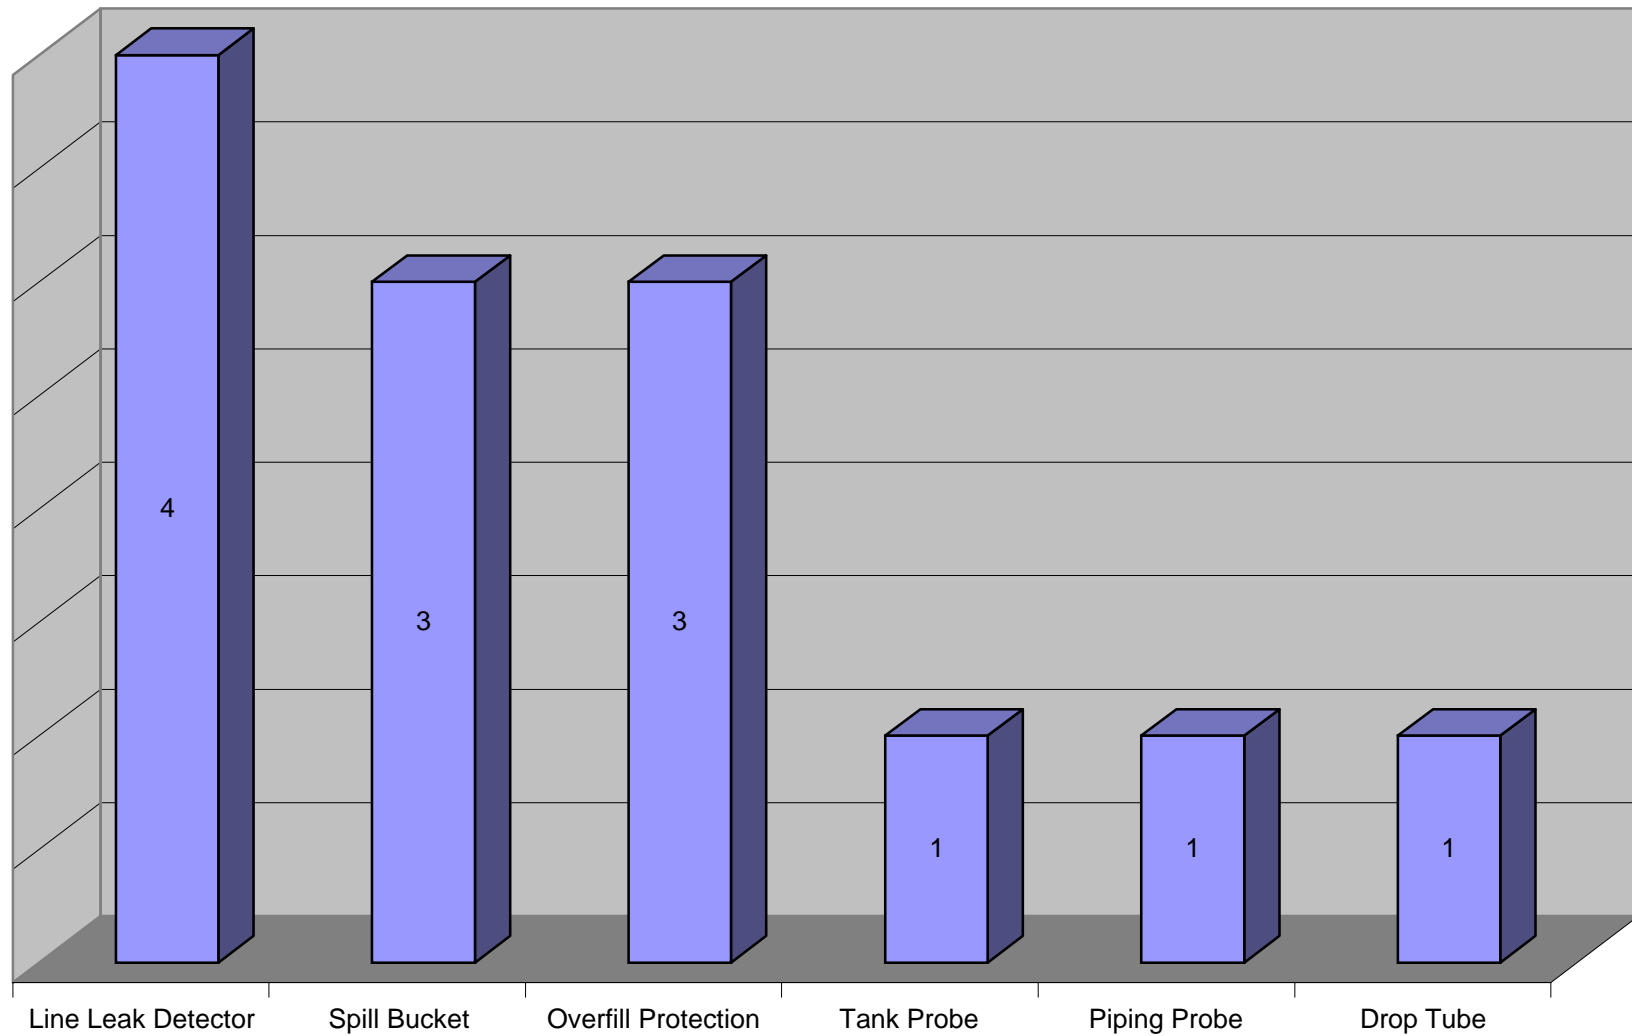
Figure C-2. What Kinds of Problems Were Discovered During Single Owner Annual Inspections in 1999?
